## INSULATION COORDINATION OF CIRCUIT BREAKERS DURING OPERATION

A. L. Streater\*  
Associate Member AIEE

W. R. Wilson\*  
Member AIEE

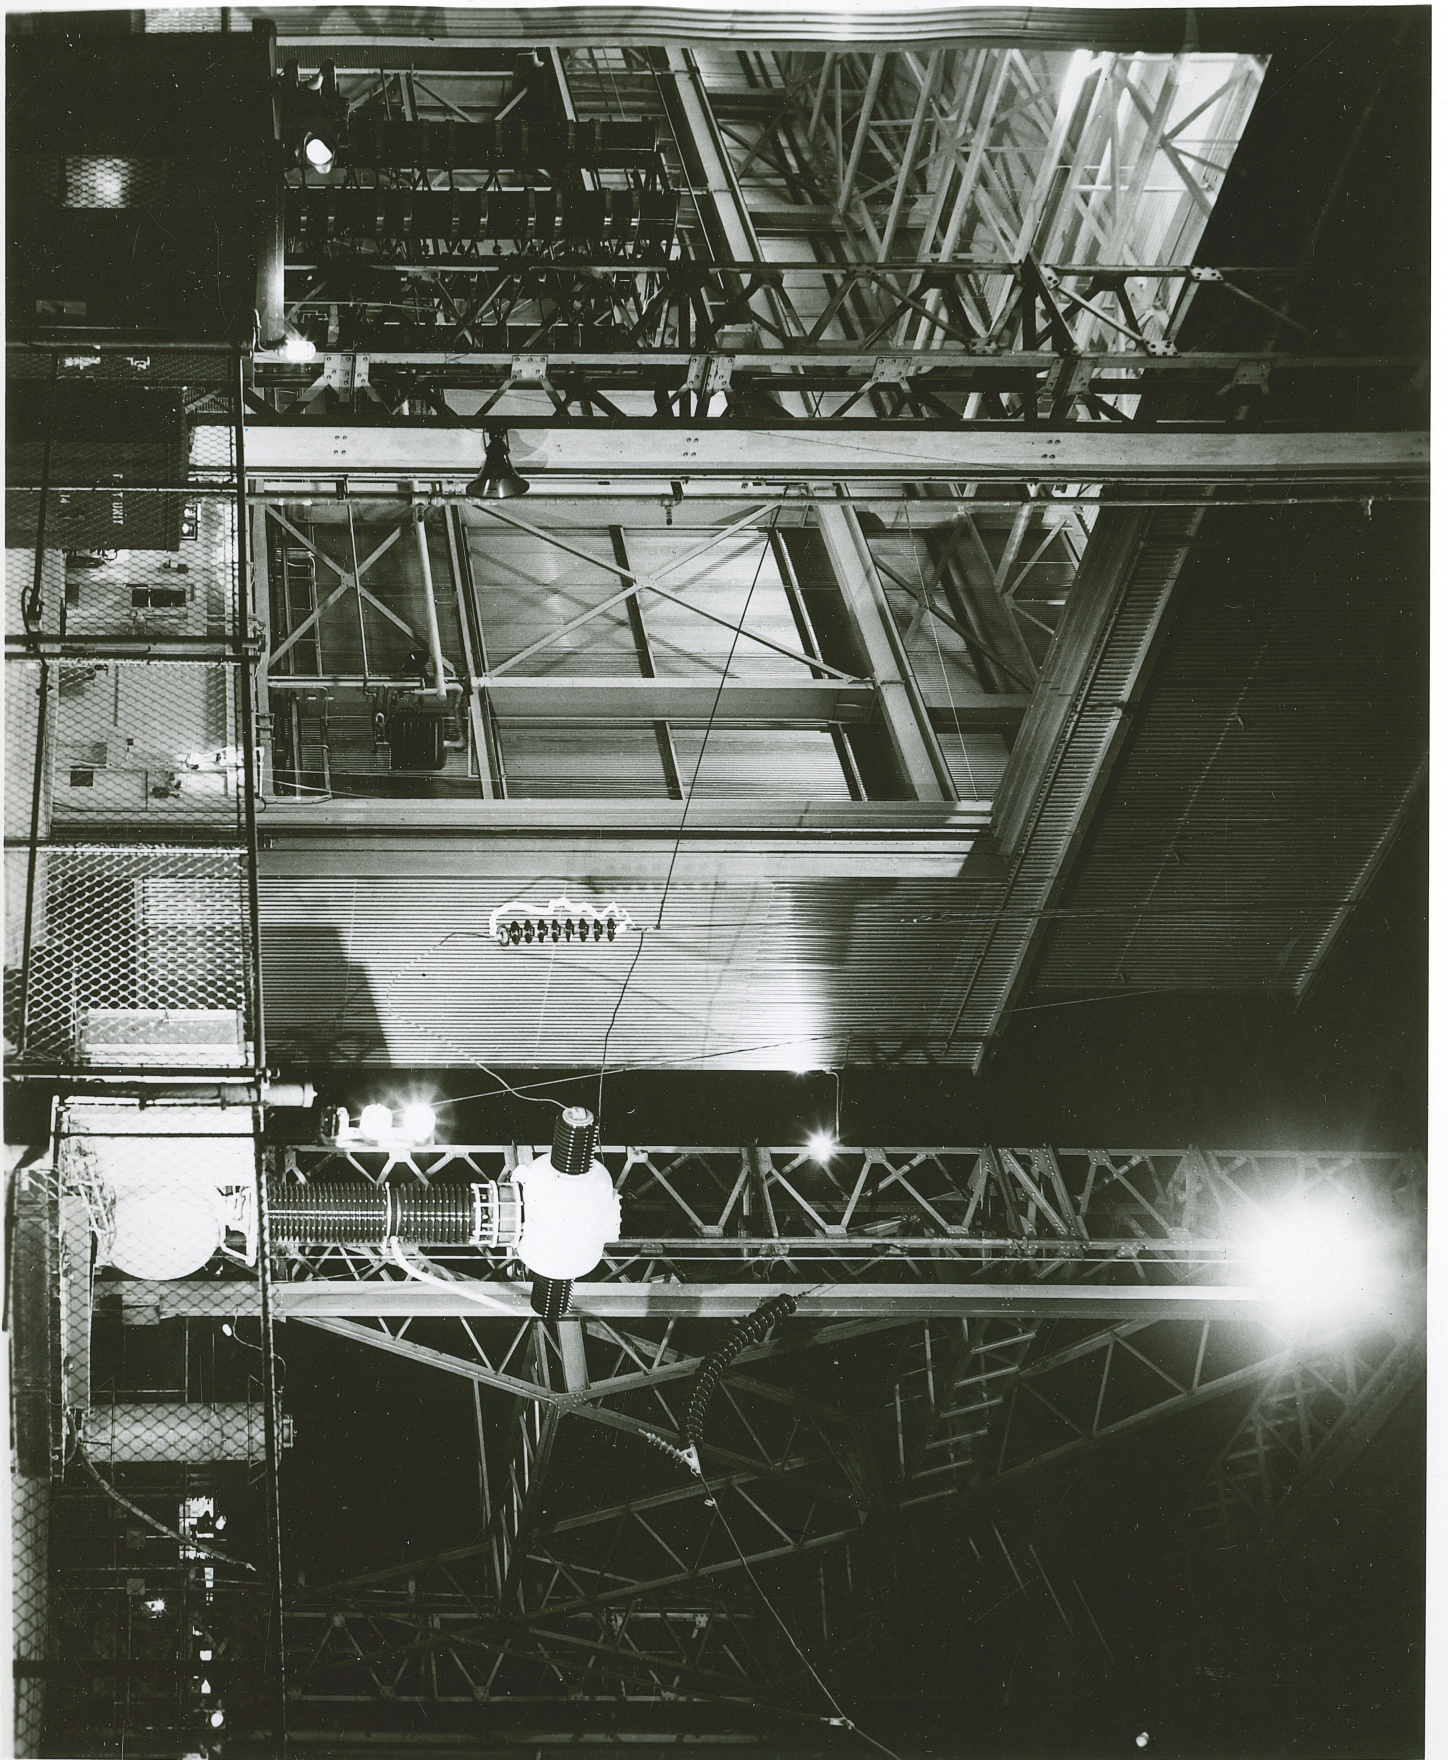
Fig. 9 New High Voltage Laboratory constructed adjacent to high power test facilities of the Development Laboratory for evaluation of multiple lightning performance of power circuit breakers during operation.

12. To advance understanding and to lead to the design of products with further reductions in the slight risk of trouble due to lightning, the new High Voltage Laboratory shown in Fig. 9 has been constructed to apply impulse voltages during power circuit interruption tests at the Development Laboratory.
